FORMER RODDY RANCH GOLF COURSE HABITAT RESTORATION AND PUBLIC ACCESS PLAN

Existing Conditions Report

March 8, 2021

Restoration Design Group

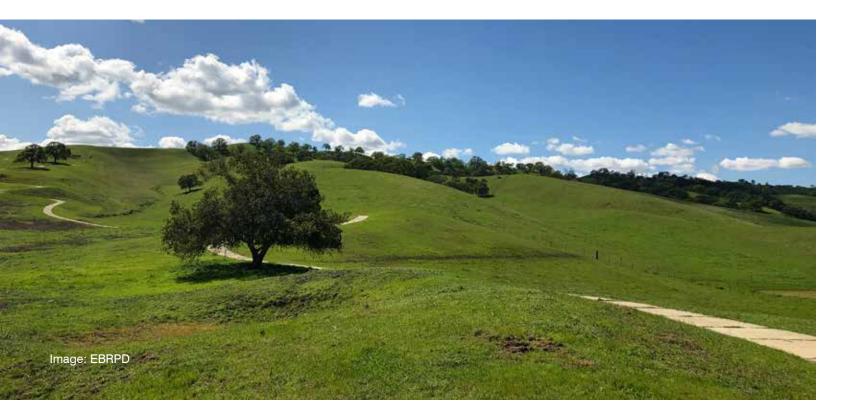
FIGURE 1 STUDY AREA MAP (RDG, 2021)

The 230-acre former Roddy Ranch Golf Course property occupies a northeastfacing slope of a northwest trending ridge between 340-590 feet above mean sea level. It is entirely within the City of Antioch, 6.25 miles south of downtown Antioch. It is west of Deer Valley Road, south of Empire Mine Road, and north of Chadbourne Road (Figure 1).

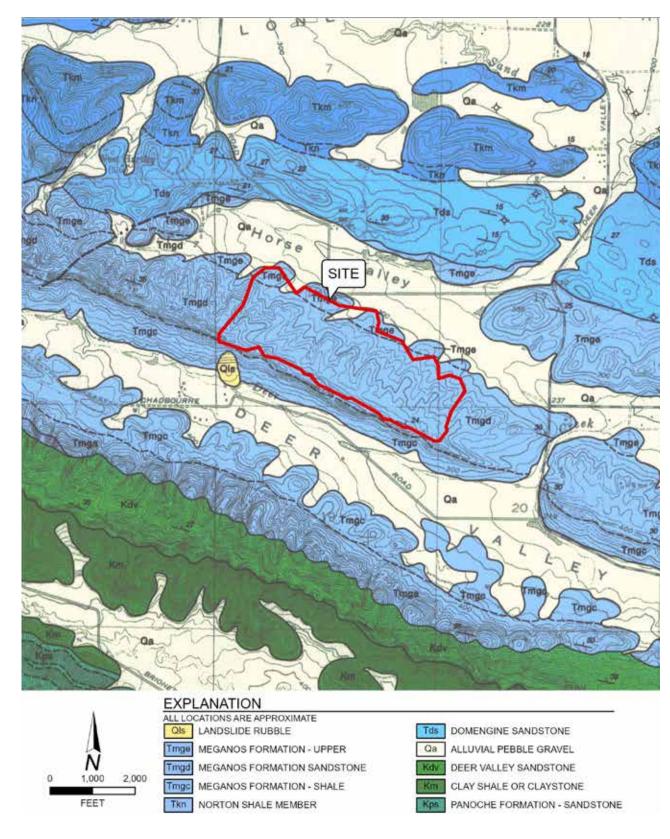
FIGURE 3 REGIONAL GEOLOGIC MAP (ENGEO, 2020)

The former Roddy Ranch Golf Course sits near the southeastern terminus of a ridge overlooking southern Antioch and Brentwood. The ridge is one in a series of ridges that extend from Mount Diablo to the broad plain of eastern Contra Costa County. The bedrock underlying the ridge is interbedded marine siltstone, sandstone and shale (ENGEO, 2020) (see Figure 3. Regional Geologic Map).

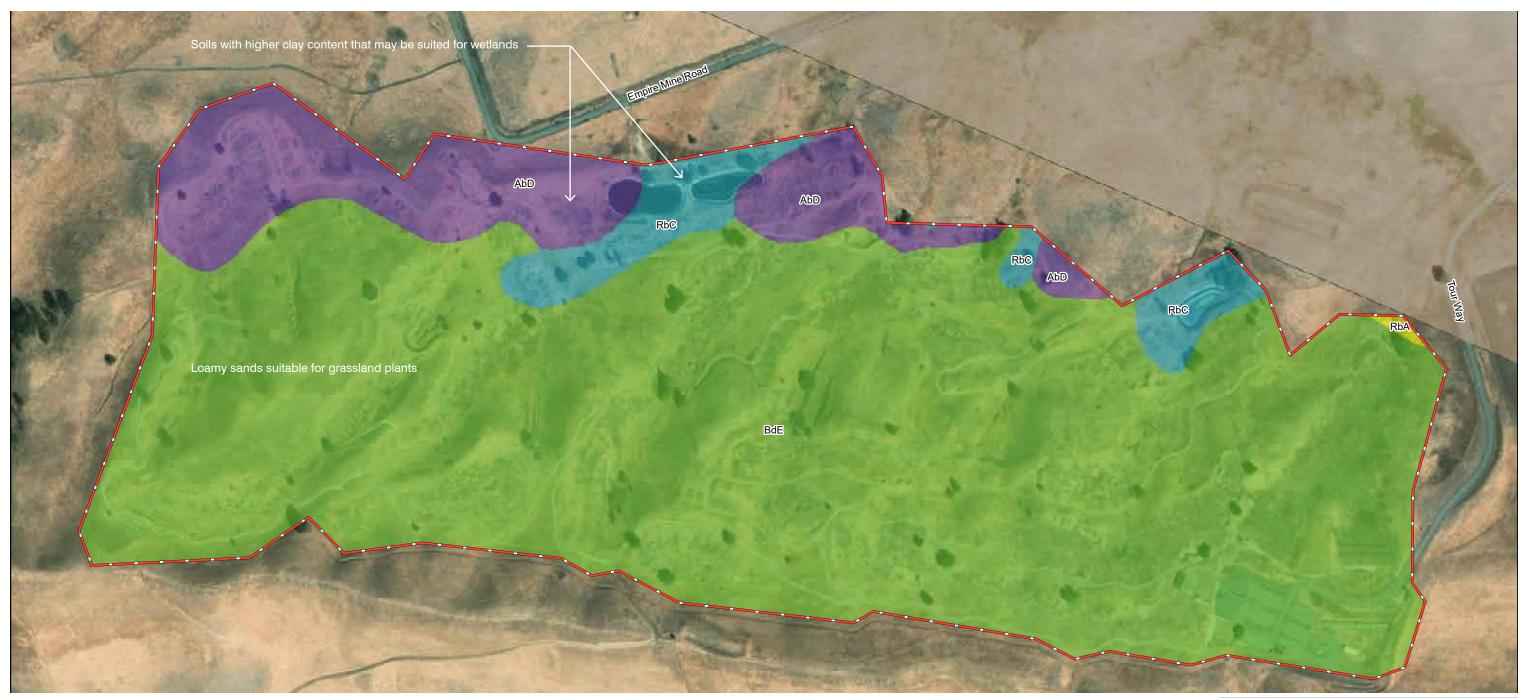
FIGURE 4 SOILS MAP (NOMAD ECOLOGY, 2020)

Most of the soils on site are Briones loamy sand (See Figure 4. Soils Map). Loam is defined as rich soils with an even balance of sand, silt, and clay and advantageous for plant growth. A loamy sand has 50% or more sand in the mixture. The site also contains small amounts of other soils types with higher clay contents along its northern boundary at the base of its slope (Nomad Ecology, 2020). The construction of the golf course moved an estimated 600,000 cubic yards of soils and imported soils for the sand traps and amendments for the greens and fairways. Some of the site is covered in soils generated from golf course grading and/or mixing of native and imported soils.

Legend Study Area Boundary Soils AbD - Altamont clay, 9 to 15 percent slopes, MLRA 15 BdE - Briones loamy sand, 5 to 30 percent slopes RbA - Rincon clay loam, 0 to 2 percent slopes, MLRA 14 RbC - Rincon clay loam, 2 to 9 percent slopes, MLRA 14

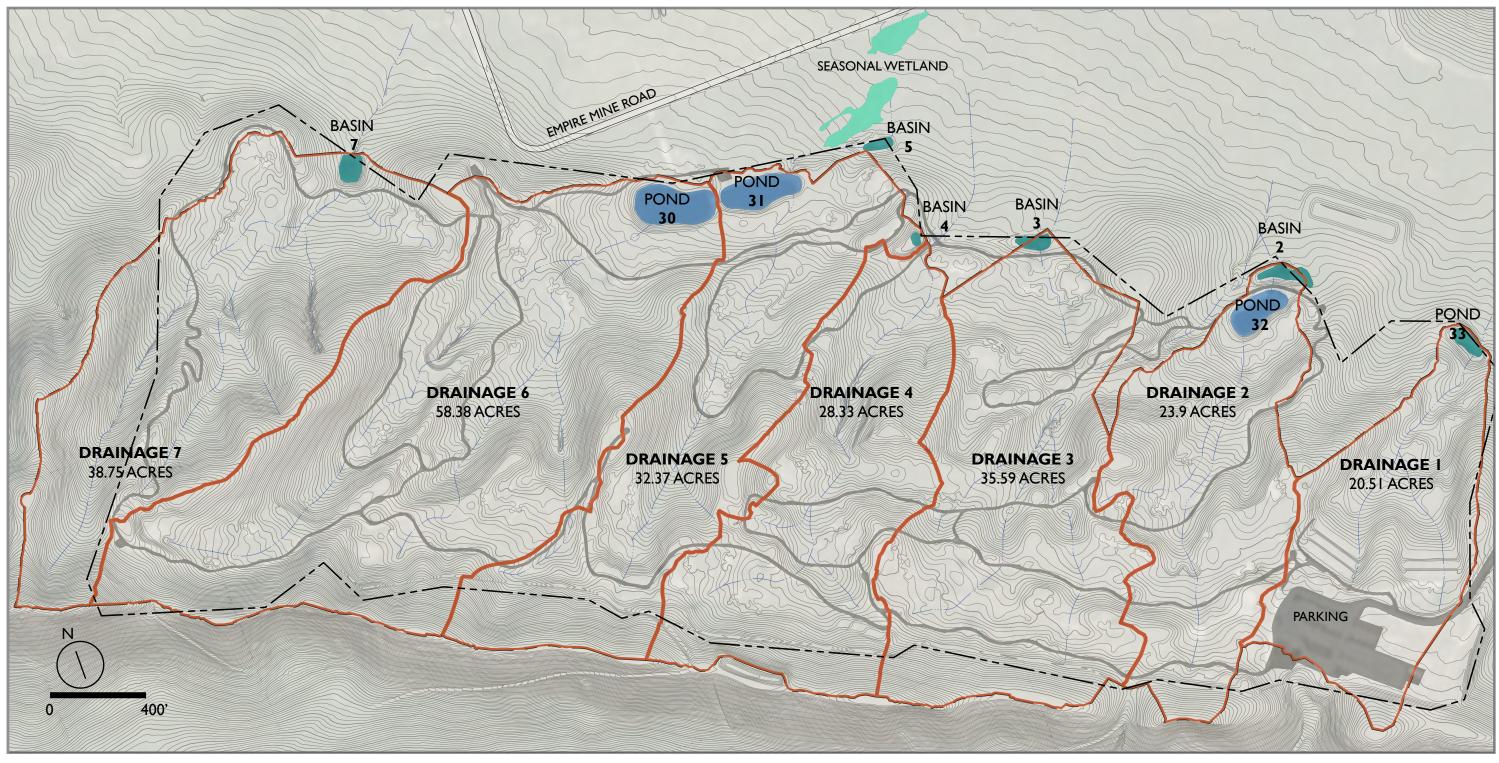
FIGURE 5 EXISTING DRAINAGE DIAGRAM (RDG, 2020)

Seven small drainages (20 to 60 acres each) currently drain the hill slope at the former Roddy Ranch Golf Course (see Figure 5. Existing Drainage Diagram). Each drainage descends approximately 260 feet in elevation across approximately 2,100 linear feet from top to bottom. A defined channel occurs at the base of the steeper drainages. Each drainage flows north off the site into a network of grassy swales and shallow depressions that collect along the shoulder of Empire Mine Road (RDG, 2020a).

DRAINAGE AREA BOUNDARY (E) GOLF CART PATH

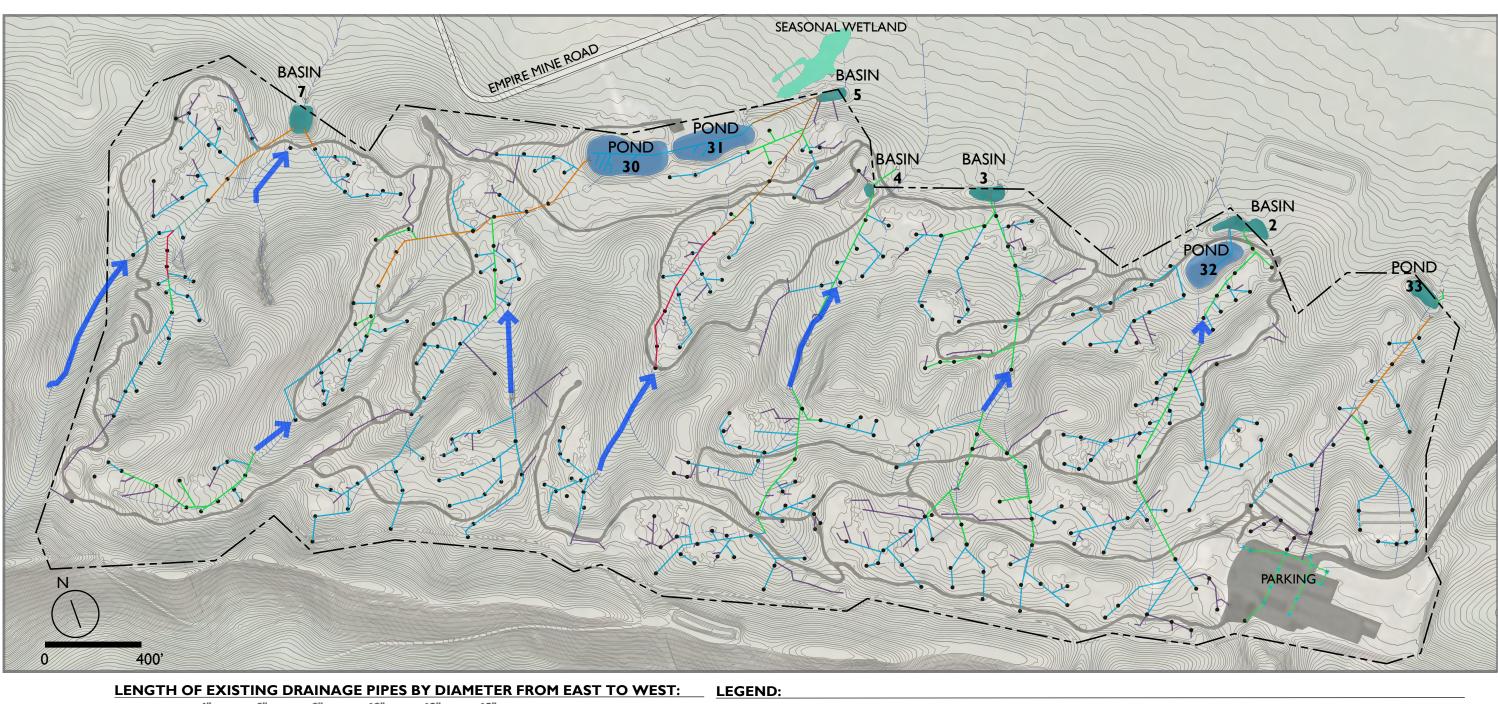
FIGURE 6 STORM DRAIN NETWORK (RDG, 2020)

The construction of the golf course included installing approximately ten miles of drainpipe for the storm drain network (See Figure 6. Storm Drain Network). By diverting runoff into pipes underground, the storm drain network provided slope and channel stability. If the network deteriorates and runoff occurs on the surface, it could result in excessive erosion (RDG, 2020a).

• The site currently relies on the storm drain network to convey runoff. The existing storm drain network will require frequent maintenance to remain functional and to avoid erosion along the existing channels.

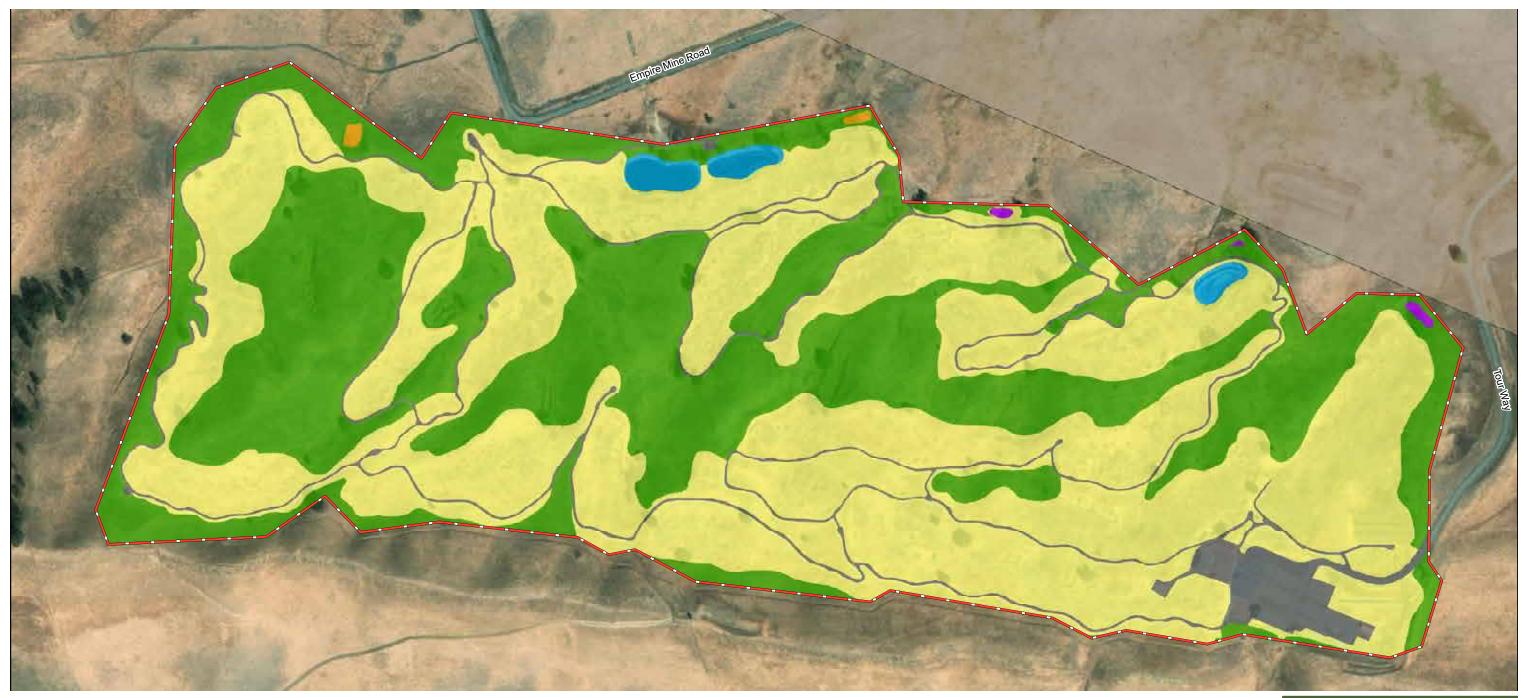
FIGURE 7 LAND COVER MAP (NOMAD ECOLOGY, 2020)

Annual grasslands are the dominant land cover of the project site outside the former golf course fairways, greens, and infrastructure (see Figure 7. Land Cover). Annual grassland is characterized by grass and forb species dominating the land cover and where trees and shrubs comprise less than five percent canopy cover. The dominant grass species on site are non-native annuals (Nomad Ecology, 2020).

In former fairways, greens, sand traps, and other former golf course grading, the dominant land cover is ruderal vegetation. Ruderal vegetation is characterized by sparse non-native, weedy vegetation, often occupying vacant parcels surrounded by developed areas (Nomad Ecology, 2020).

Study Area Boundary
 Field-Verified Land Cover

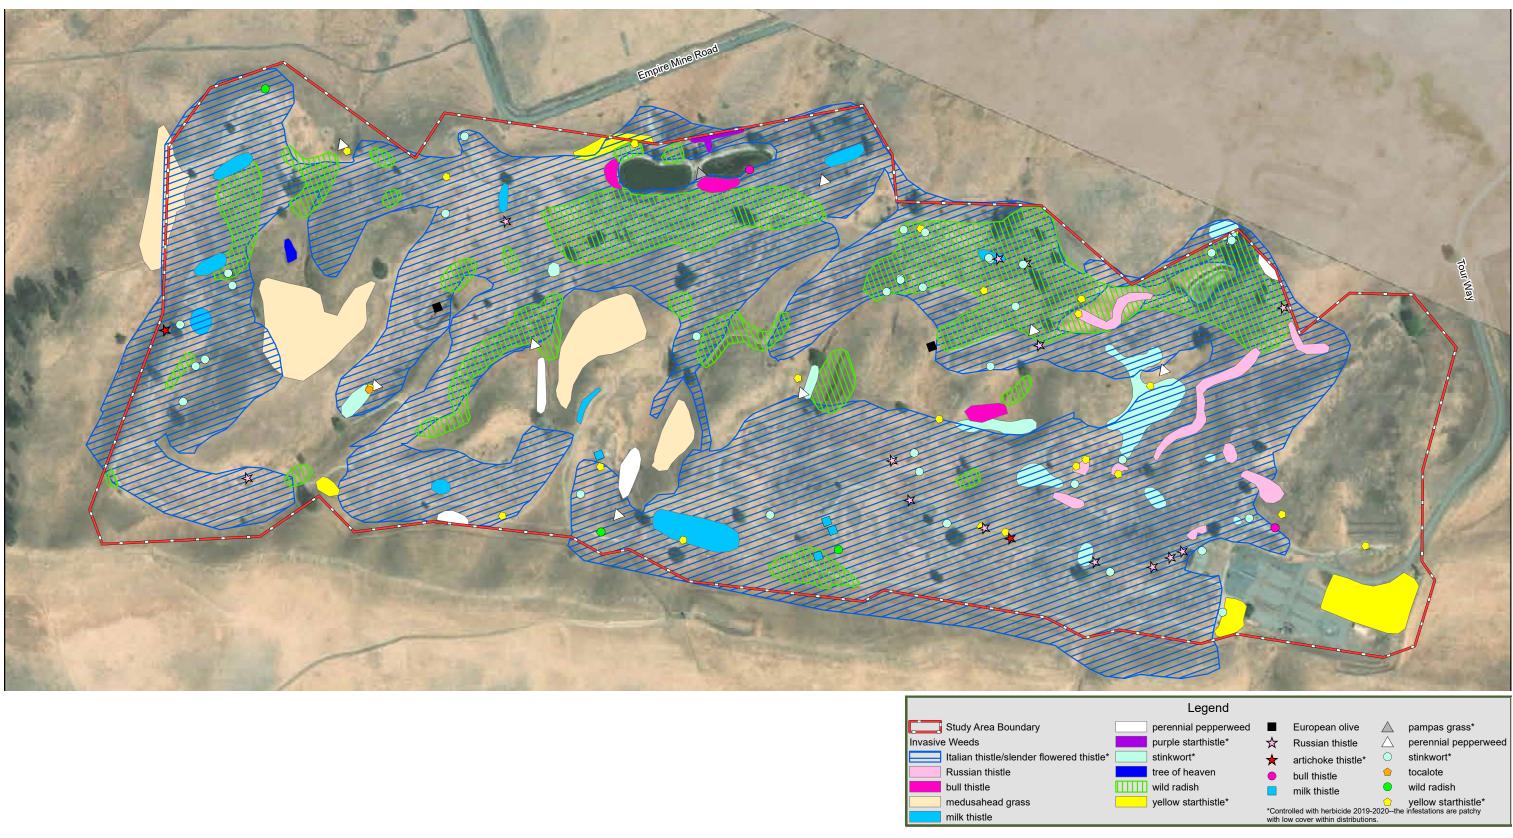
FIGURE 8 INVASIVE WEEDS MAP (NOMAD ECOLOGY, 2020)

A non-native plant species is defined as a species that is occurring outside of its native distributional range and the species has arrived there by human activity. Seventeen non-native plant species of concern were observed within the study area (see Figure 8. Invasive Weeds Map):

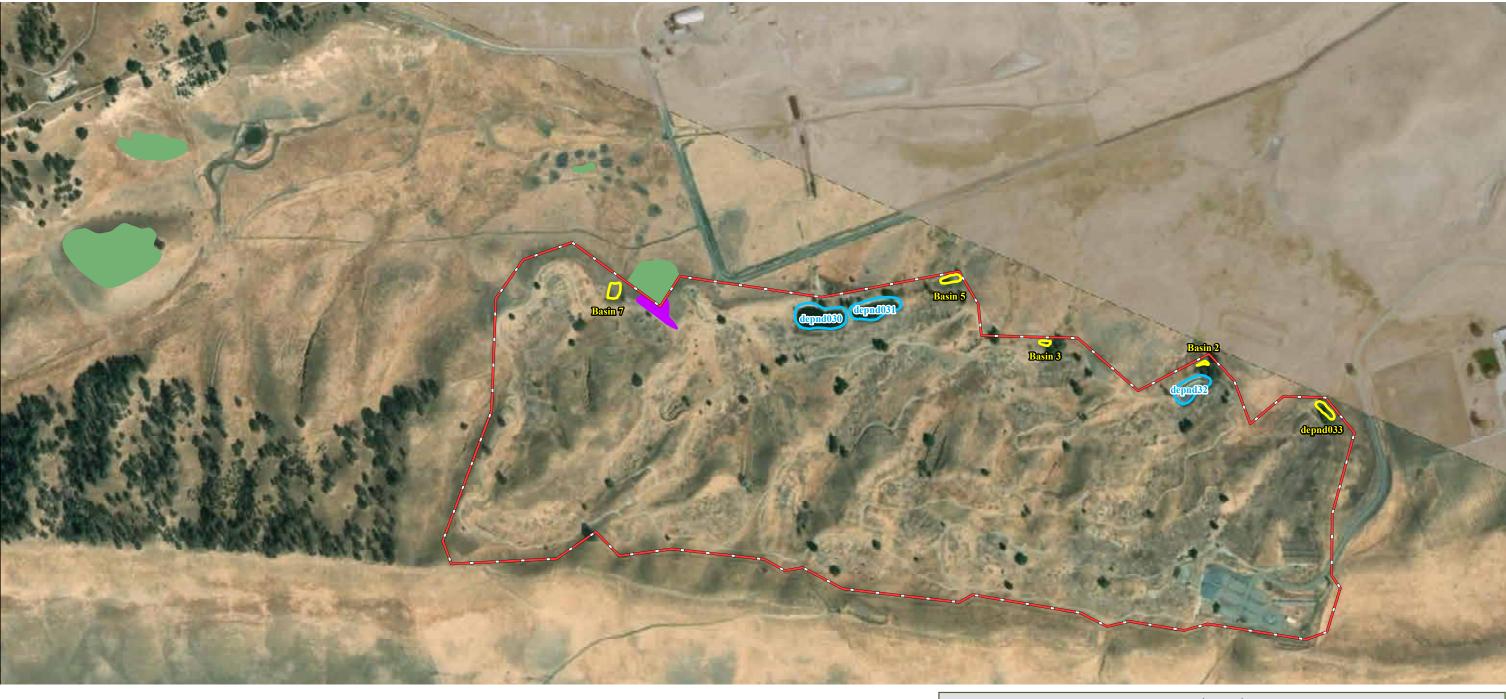
FIGURE 9 BIG TARPLANT POPULATION IN THE STUDY AREA AND VICINITY (NOMAD ECOLOGY, 2020)

Within the project site, big tarplant occured in annual grassland in heavy clay soil on a northwest facing slope adjacent to a golf course path, just east of Basin 7 (see Figure 9. Big Tarplant Population in the Study Area and Vicinity). The colony consists of approximately 400 individuals on the project site and continues on the adjacent property.

Big tarplant (Blepharizonia plumosa) Population Locations In the Study Area (approx. 400 Individuals) Off Site (approx 15,000 Individuals)

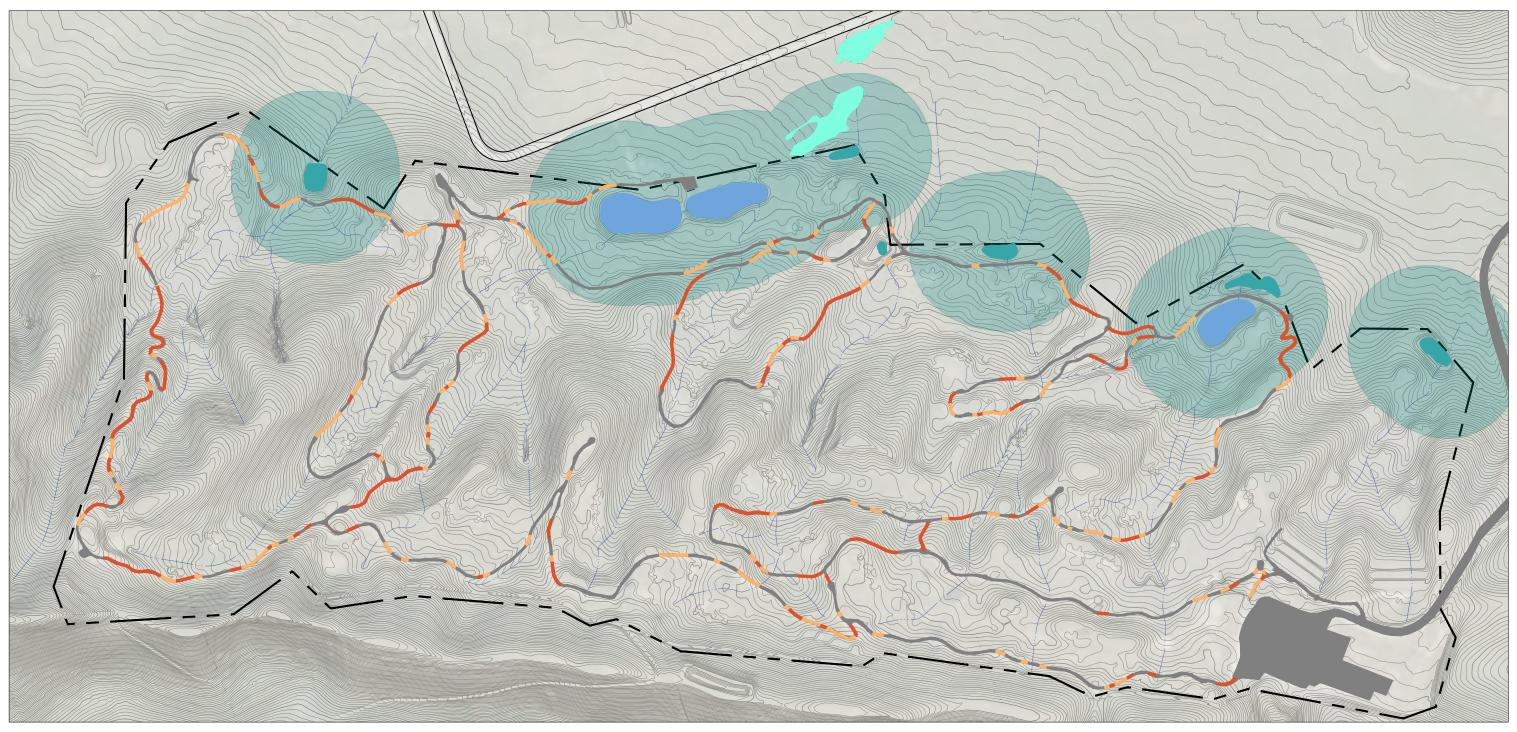
FIGURE 10 PUBLIC ACCESS CONSTRAINTS (RDG, 2021)

The existing golf cart paths provide a foundation for the future trail network. However, to meet accessibility guidelines, trails should be planned to minimize steep slopes. Figure 10. Public Access Constraints shows sections of the existing path network that fail to meet accessibility guidelines concerning running slope. In addition to steep running slopes, many of the existing trails' cross slopes are greater than 2%. Outdoor recreation accessibility guidelines suggest that cross slopes for concrete or asphalt should not be steeper than 2%, while trails made of pervious material should not be steeper than 5% (United States Access Board, 2014).

ACCESSIBILITY GUIDELINES FOR OUTDOOR DEVELOPED AREA MAXIMUM RUNNING SLOPE AND SEGMENT LENGTH:

MAXIMUM	RUNNING SLOPE AND SE	GMENT LENGTH:	LEGEND:	
			PROPERTY LINE	📕 (E) GO
Running Slopes	on Outdoor Recreation		(E) CONTOUR (2'-10')	THAN
Ac	cess Routes	Maximum Length of Segment	(E) GOLF CART PATH	📕 (E) GO
Steeper than	But not Steeper Than		(E) CHANNEL	THAN
1:20 (5 percent)	1:12 (8.33 percent)	50 feet (15 meters)	1	🔲 300' W

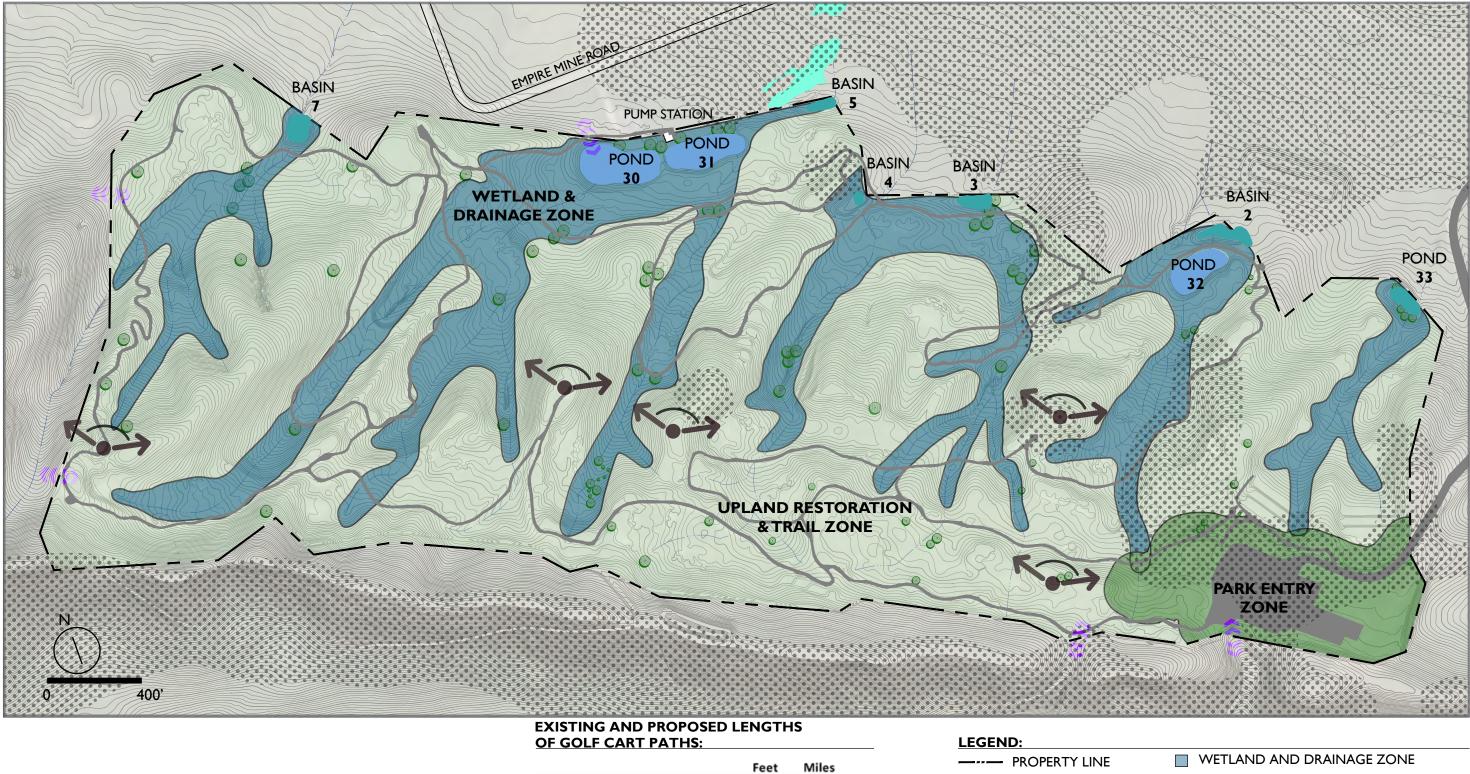
FIGURE 11 SITE ANALYSIS DIAGRAM (RDG, 2021)

GOLF CART PATH RUNNING SLOPES GREATER

WETLAND BUFFER ZONE FOR HABITAT
